# A Creek Without a Name Becomes a Community Asset

By L. Peter MacDonagh, RLA  
and Elizabeth I. Ryan, RLA

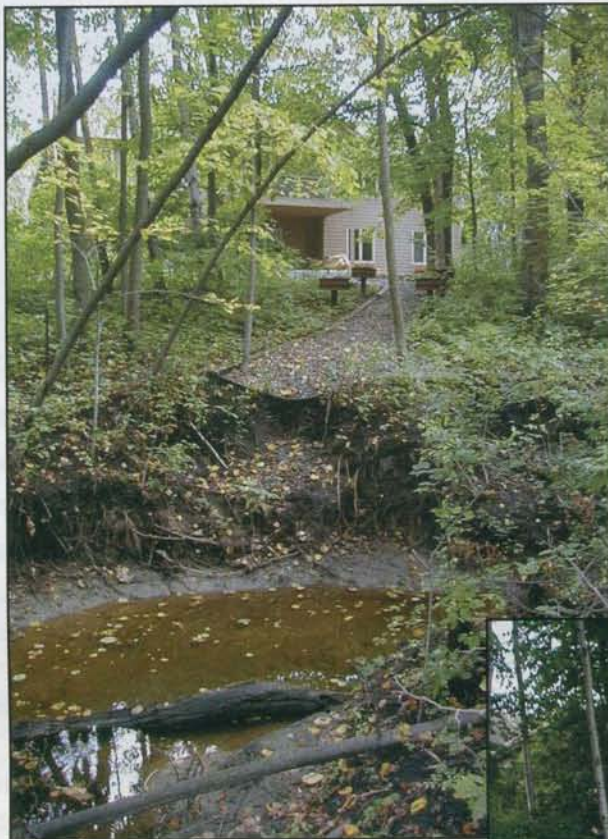
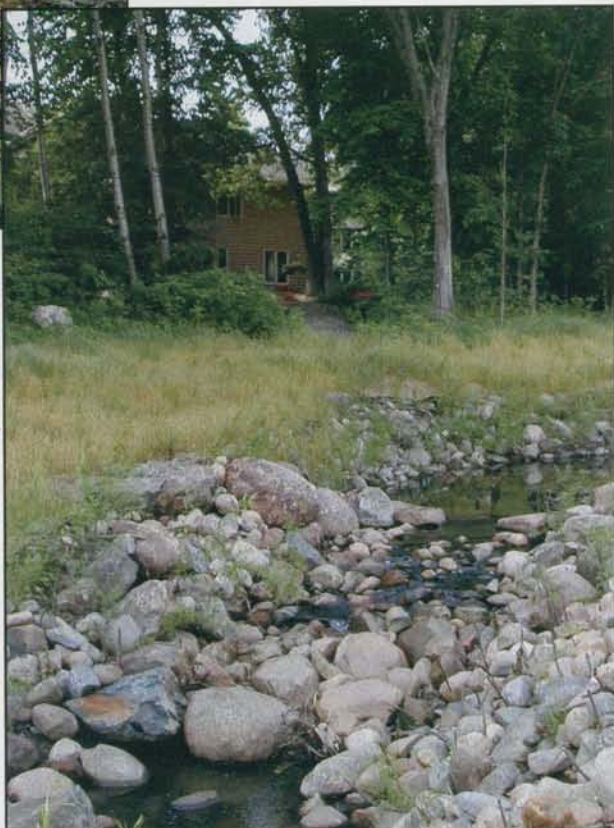
**Top:** Increased stormwater runoff in the watershed was causing Pike Creek to severely erode its banks, leading to property damage and poor water quality downstream. **Inset:** The same view as above shows the combination of hard armor and soft armor bioengineering techniques used to successfully stabilize the channel.

The entrenched creek channel above bankfull at point bars was widened to increase storage capacity during flood events. Rock vanes were installed for stream gradient control to stop head-cutting. Hard armor protection included root-wads and fieldstone were applied where the bank was subjected to the greatest erosive forces. Rock Gabions (rock-filled wire

baskets) were considered but had failed in the previous solutions. They were substituted with rock cross vanes which worked much better with natural stream morphology.

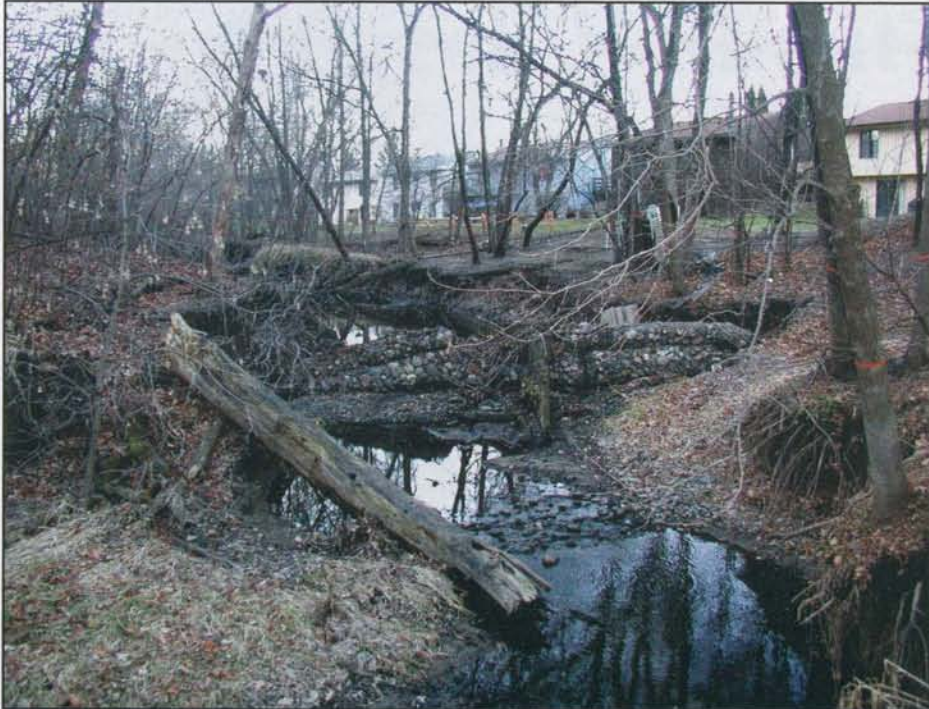
**Before:** The Pike Creek channel was a mess of previously attempted and failed stabilization structures, invasive vegetation, and low diversity degraded woodland.

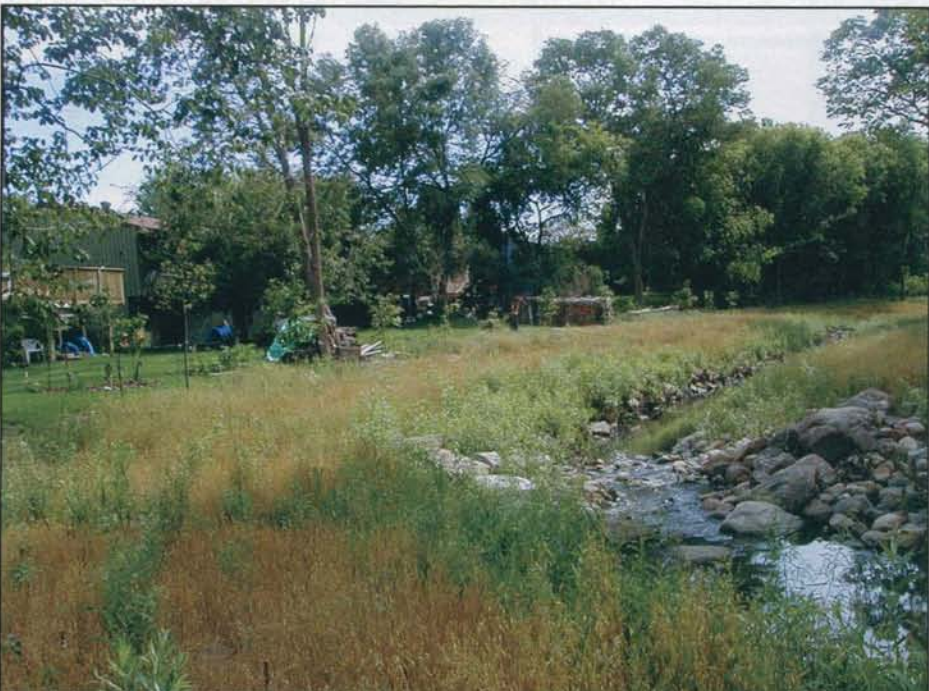
**After:** The community-endorsed design solution used native vegetation and soil bioengineering techniques to restore the Pike Channel to an open canopy, savanna/prairie plant community that is now a community asset.

In contrast to traditional stabilization techniques, which deteriorate and weaken with age, soil bioengineering techniques grow into a living, self-repairing system that gets stronger with age. Soil bioengineering will re-establish the oak savanna diversity prior to settlement, resulting in a deeper rhizosphere, shade tree thinning, exotic species removal, and boulder toe installation on cut banks.

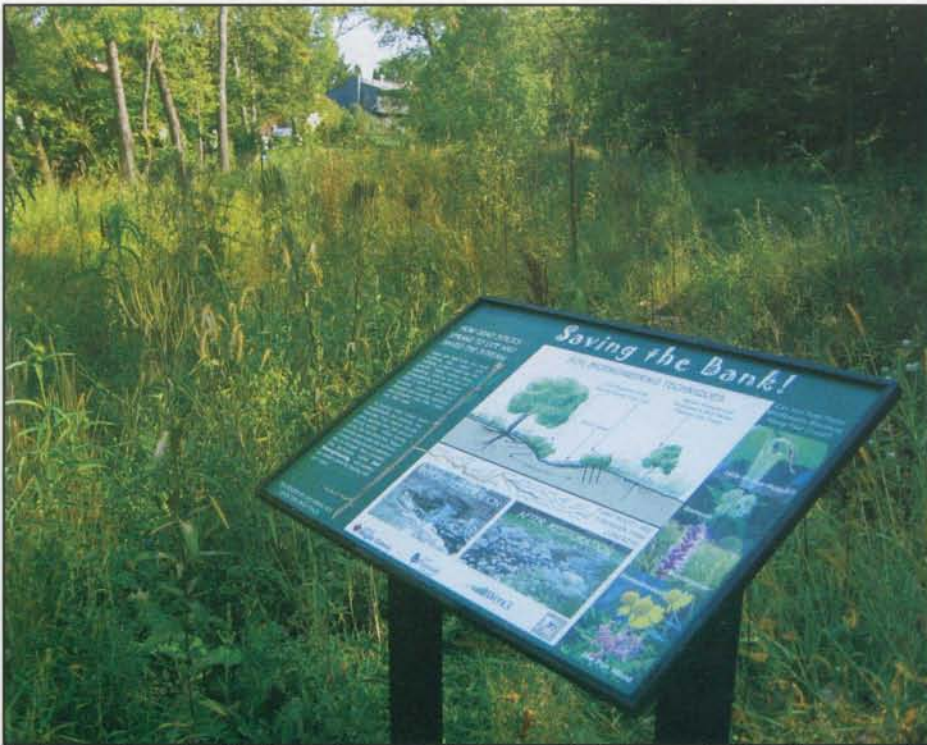
An interpretive sign illustrates the ecological concepts that were behind the successful channel stabilization.
